Auckland City Asphalt Performance Testing

- 9th November 2010

Objective of the Research

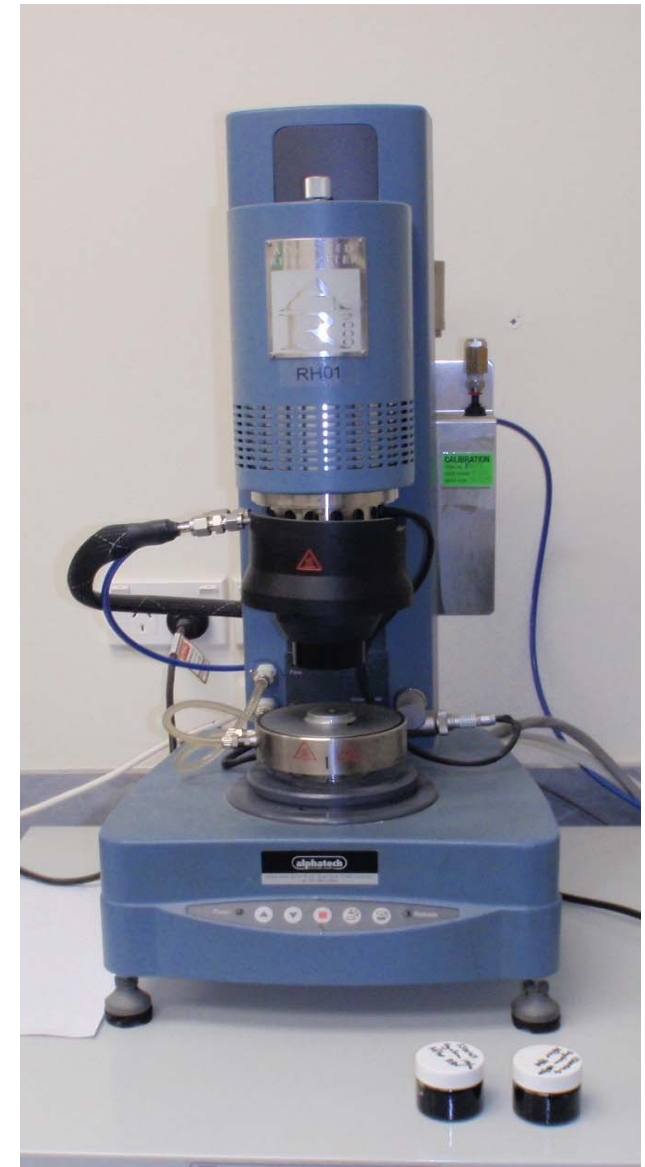
- Dynamic Shear Rheometer (DSR) can determine the performance of the binder used in the asphalt across a range of temperatures and frequencies (traffic speeds).
- The DSR can determine the Complex Modulus (Stiffness) & the Elastic/Viscous balance of a binder.

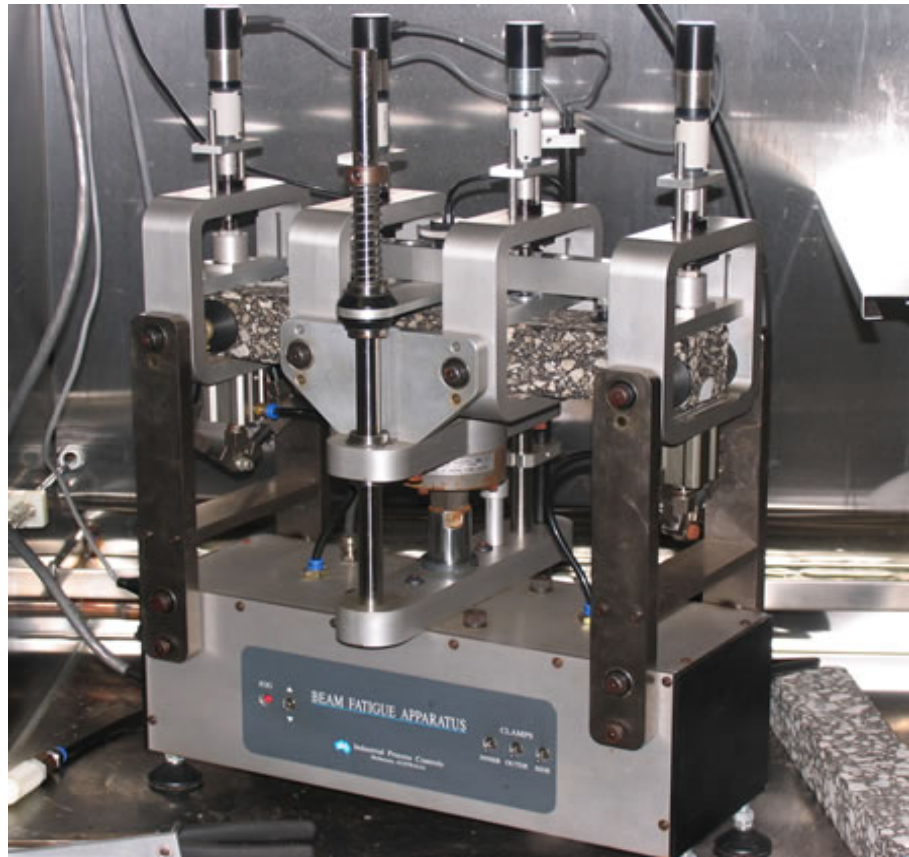
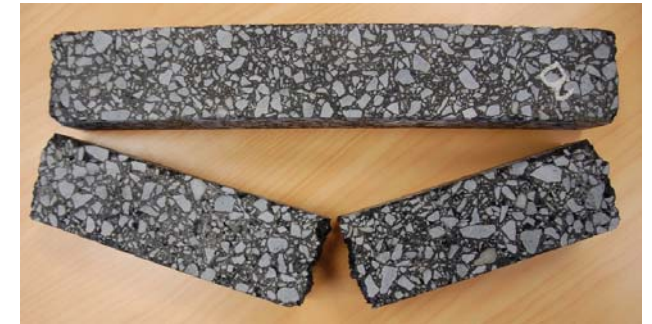
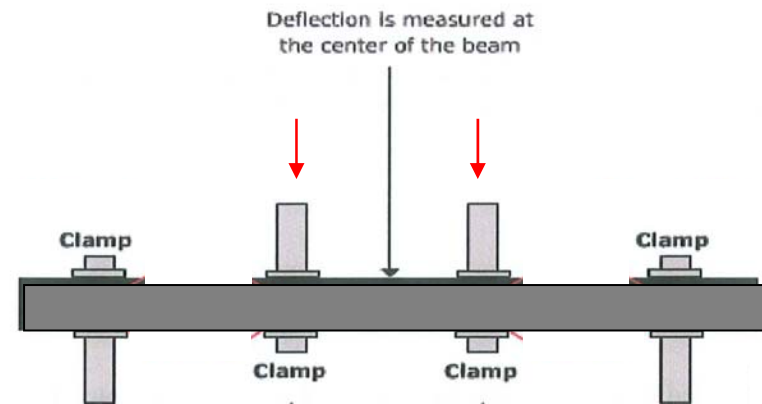
Asphalt Testing Fatigue @ 20° C

Test termination

- Stiffness reaches 50% initial value
- The beam cracks
- After 1 million cycles (record % loss in initial stiffness)

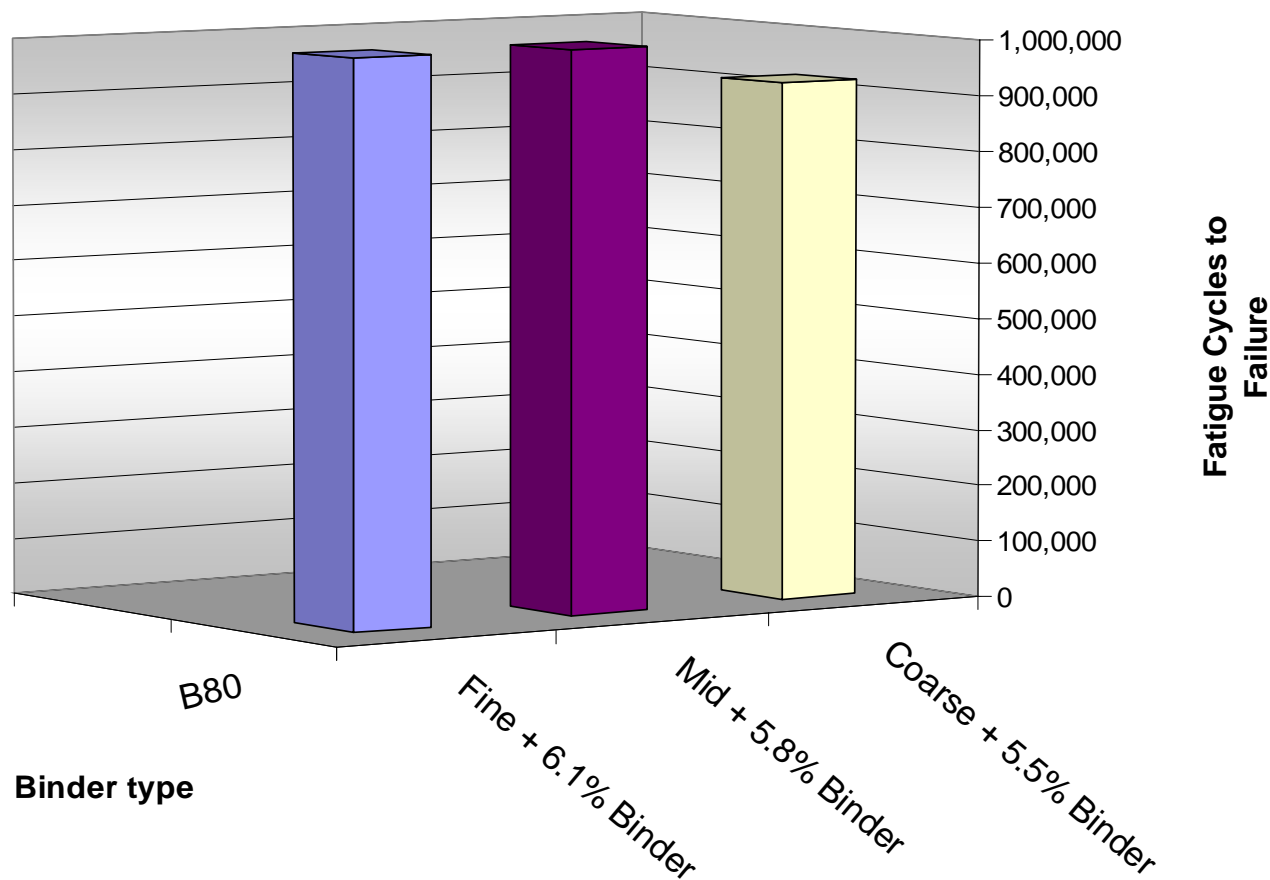
Asphalt Testing – TNZ15 B80 BB

Fatigue @ 20°C

- **Fatigue @ 20°C**
 - TNZ15 B80 performed very well in fatigue, as was expected.
 - TNZ15 HD fatigue performance is exceptional, with all gradings exceeding the 1 million cycle limit with ease.
 - AC14 B60 was quite poor, with all gradings not exceeding 0.5 million cycles.
 - AC14 HD: the substitution of conventional bitumen with InfraBond HD PMB dramatically improved the fatigue performance of this mix.

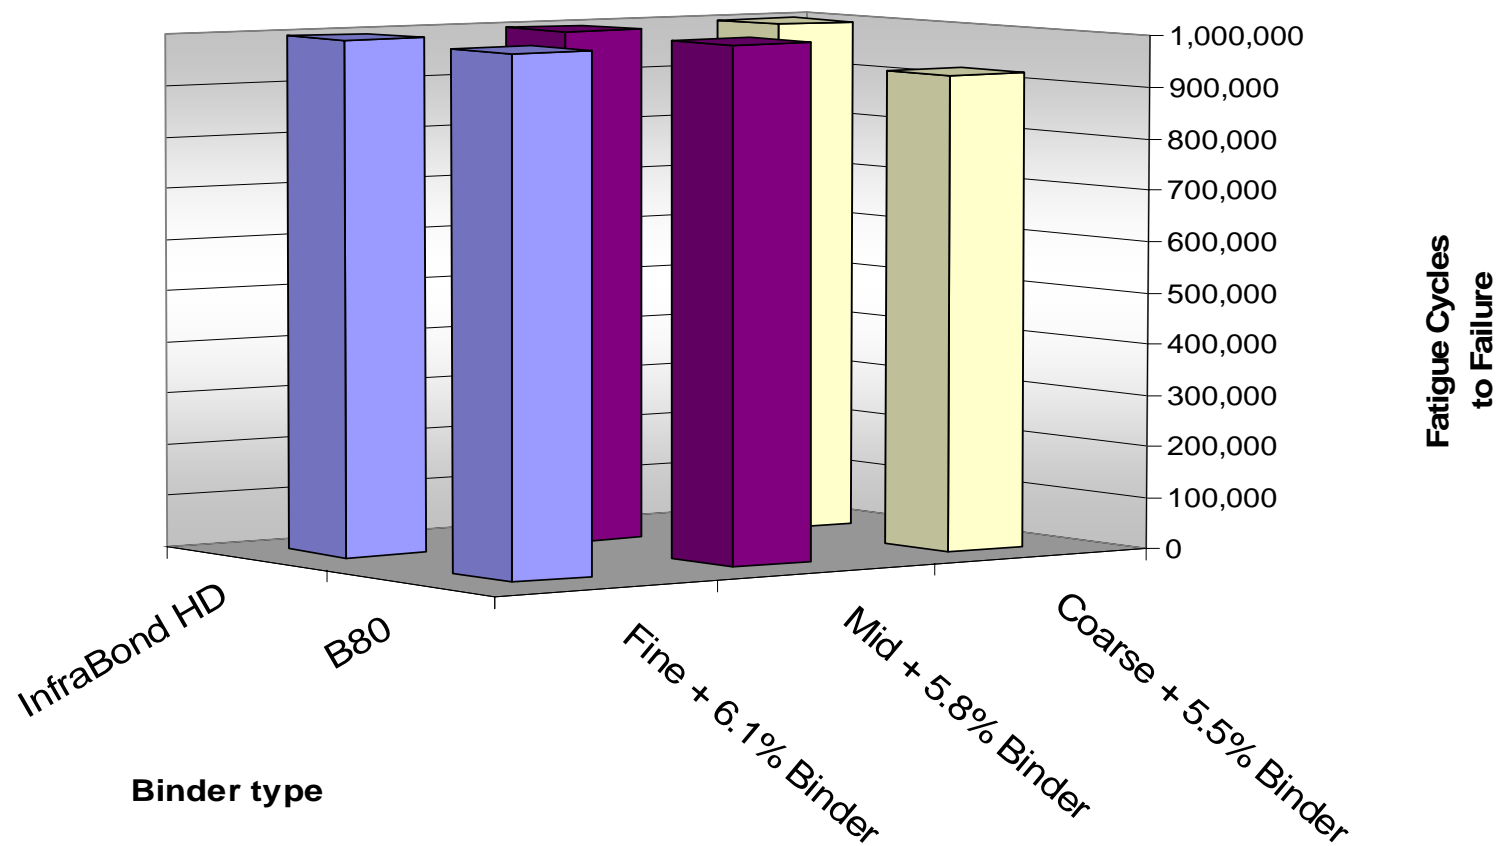
Asphalt Testing – TNZ15 B80 BB

Fatigue @ 20°C

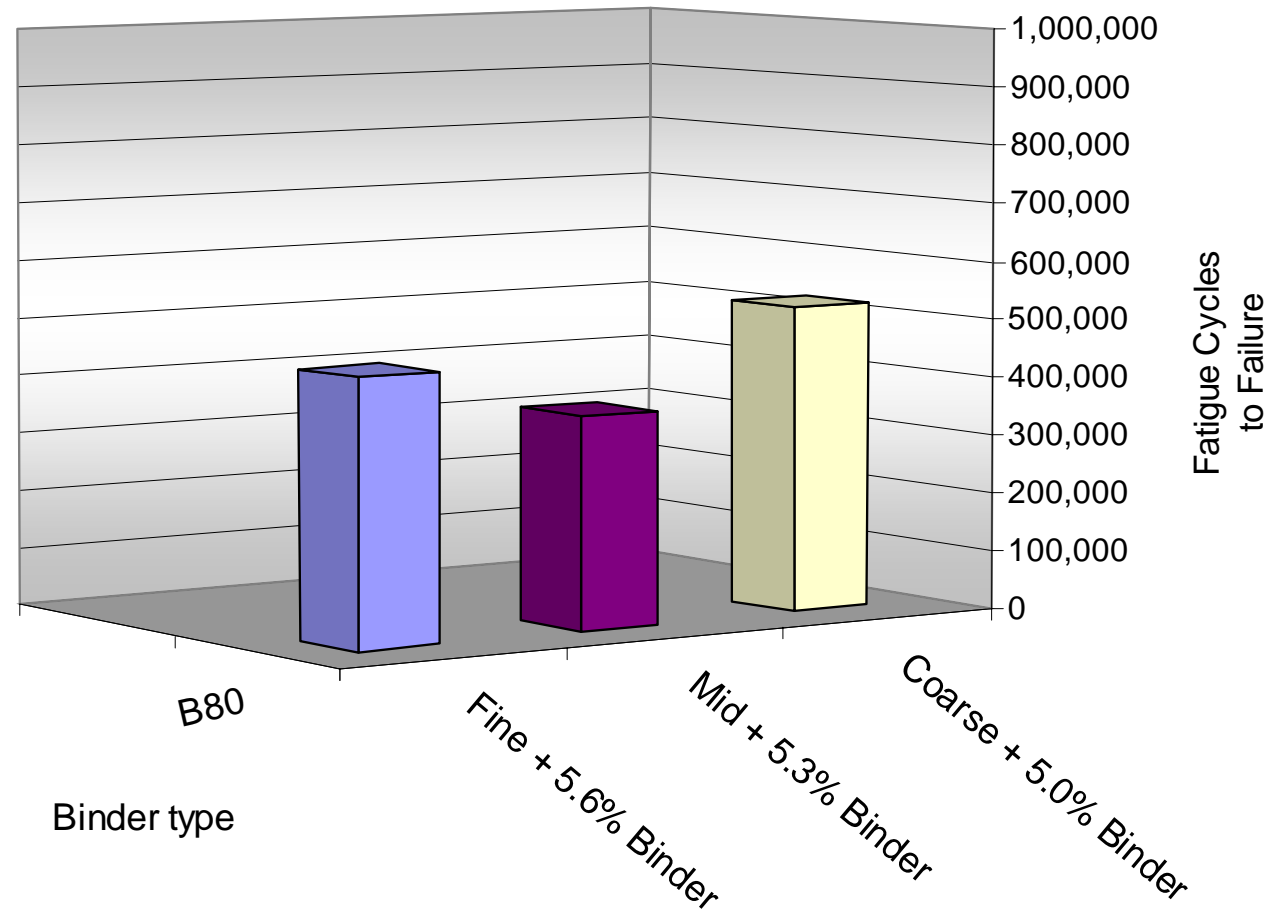
Asphalt Testing – AC14 B60 BB

Fatigue @ 20°C

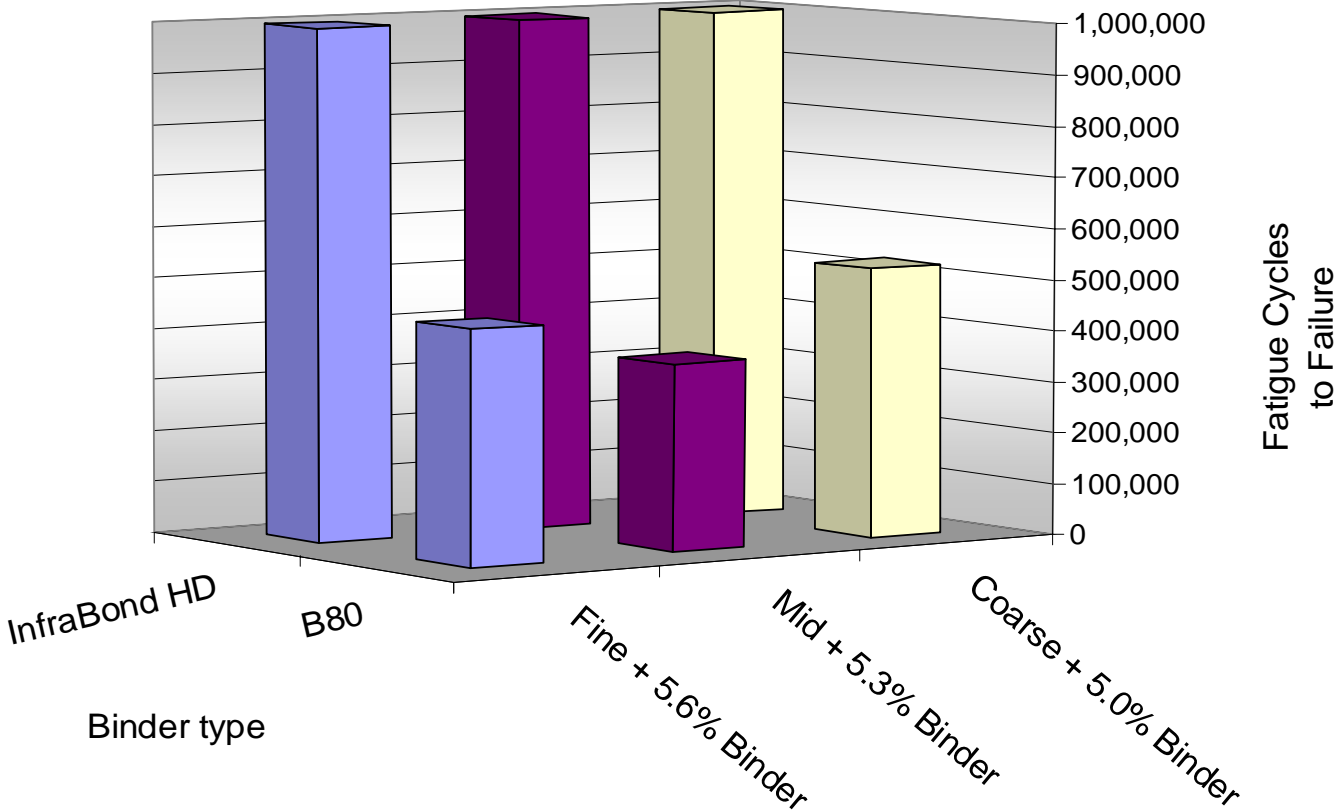
Asphalt Testing – AC14 B60 BB

Fatigue @ 20°C

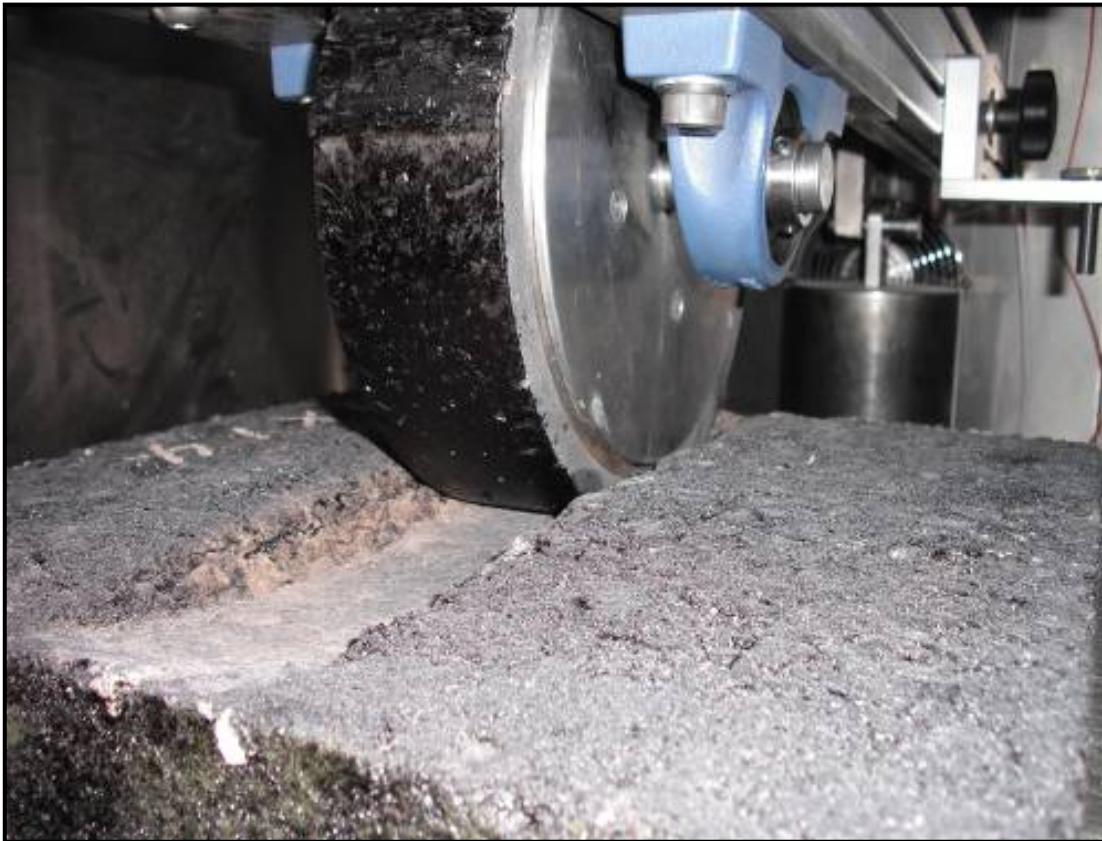
Asphalt Testing: Wheeltracking @ 60°C after 10,000 passes

- **Wheeltracking @ 60°C**
 - TNZ15 B80 is not a good rut resistant mix under repeated loading at 60°C.
 - TNZ15 HD: the substitution with the *InfraBond* HD PMB improved the rut resistance into the APRG18 “Superior” category.
 - AC14 B60 is a medium performing mix in terms of wheeltracking.
 - AC14 HD: the substitution with the *InfraBond* HD PMB improved the rut resistance of this mix into the APRG18 “Superior” category.

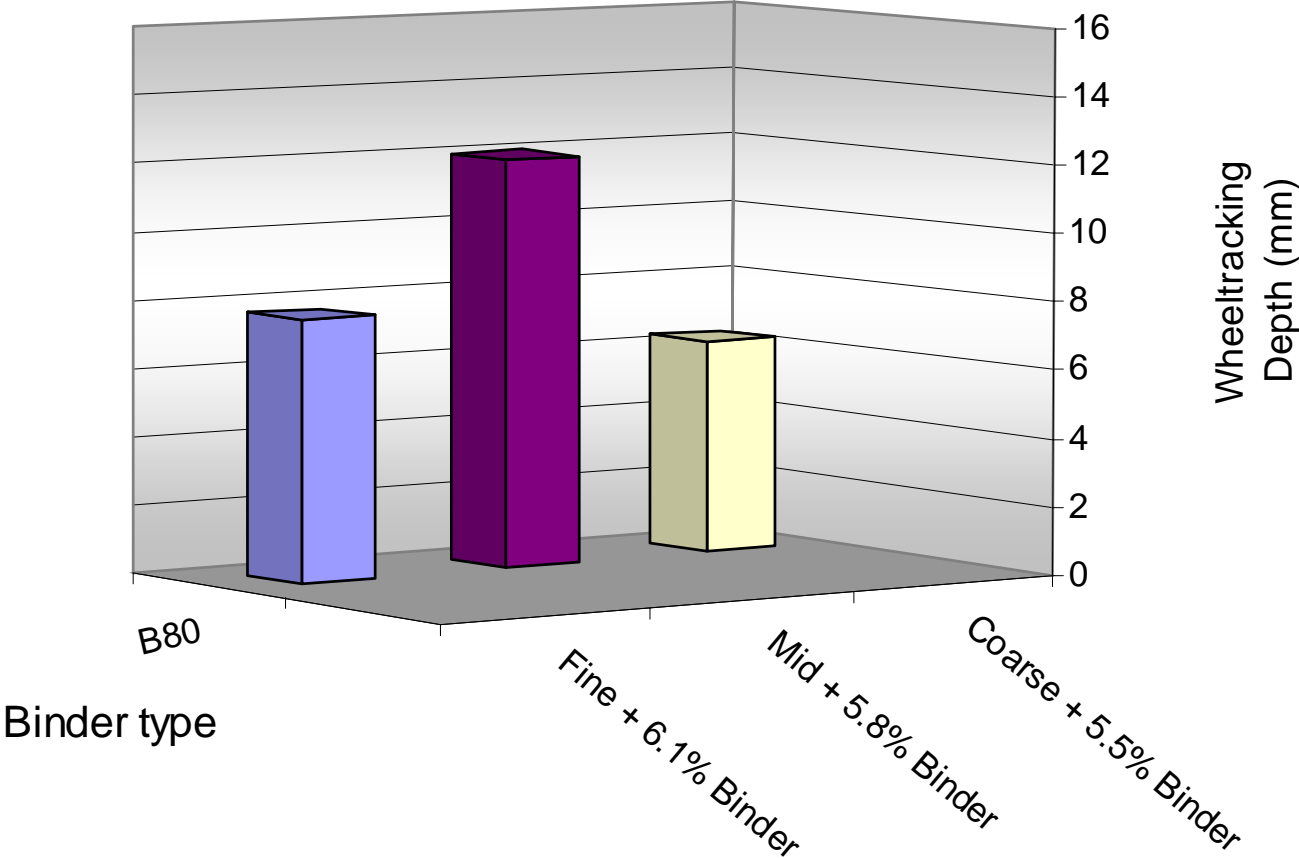
Asphalt Testing – TNZ15 B80BB

Wheeltracking @ 60 °C after 10,000 passes

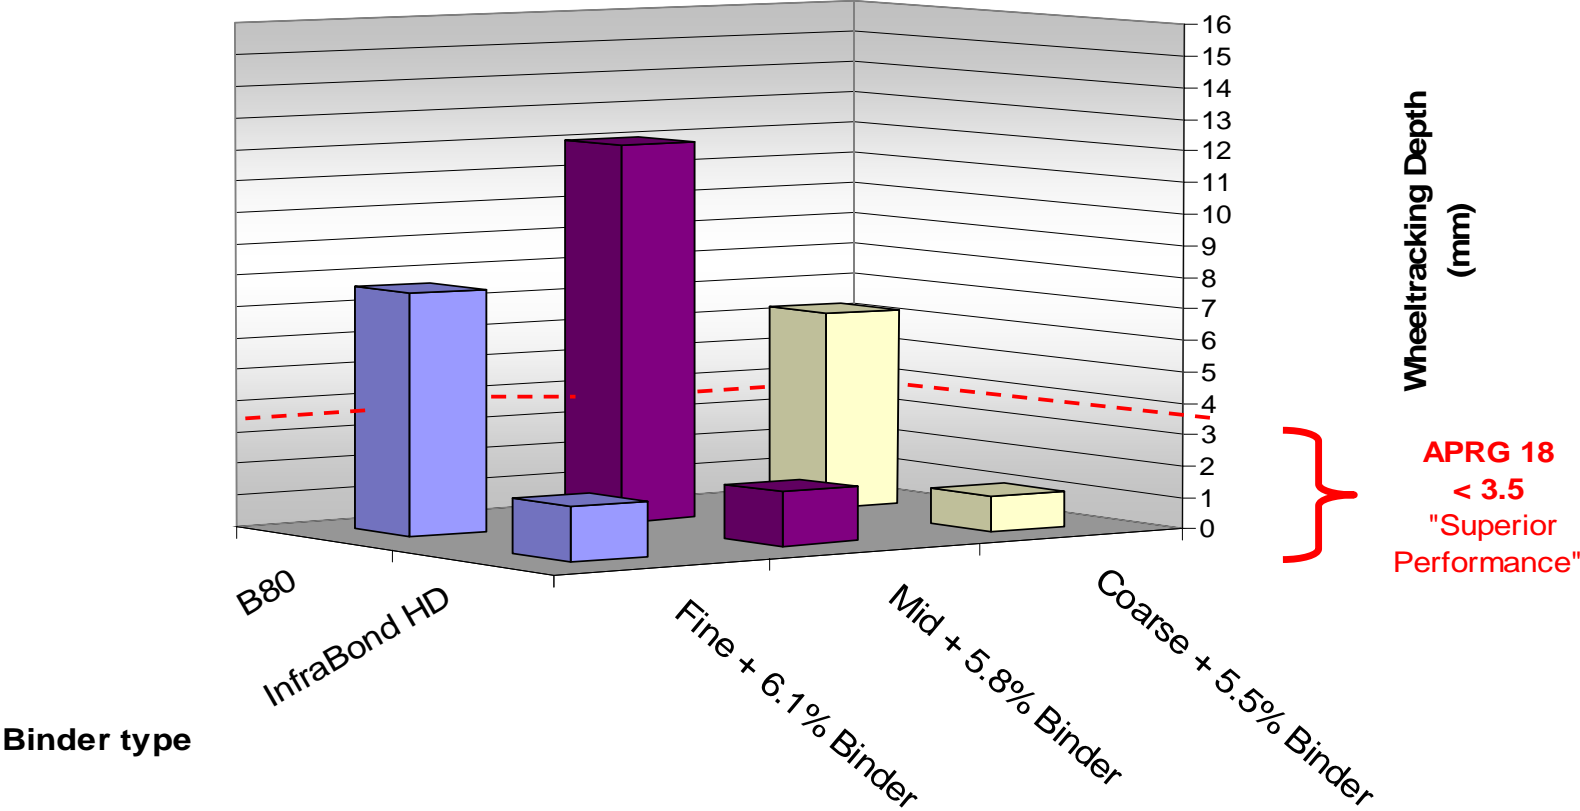
Asphalt Testing – TNZ15 B80 BB

Wheeltracking @ 60 °C after 10,000 passes

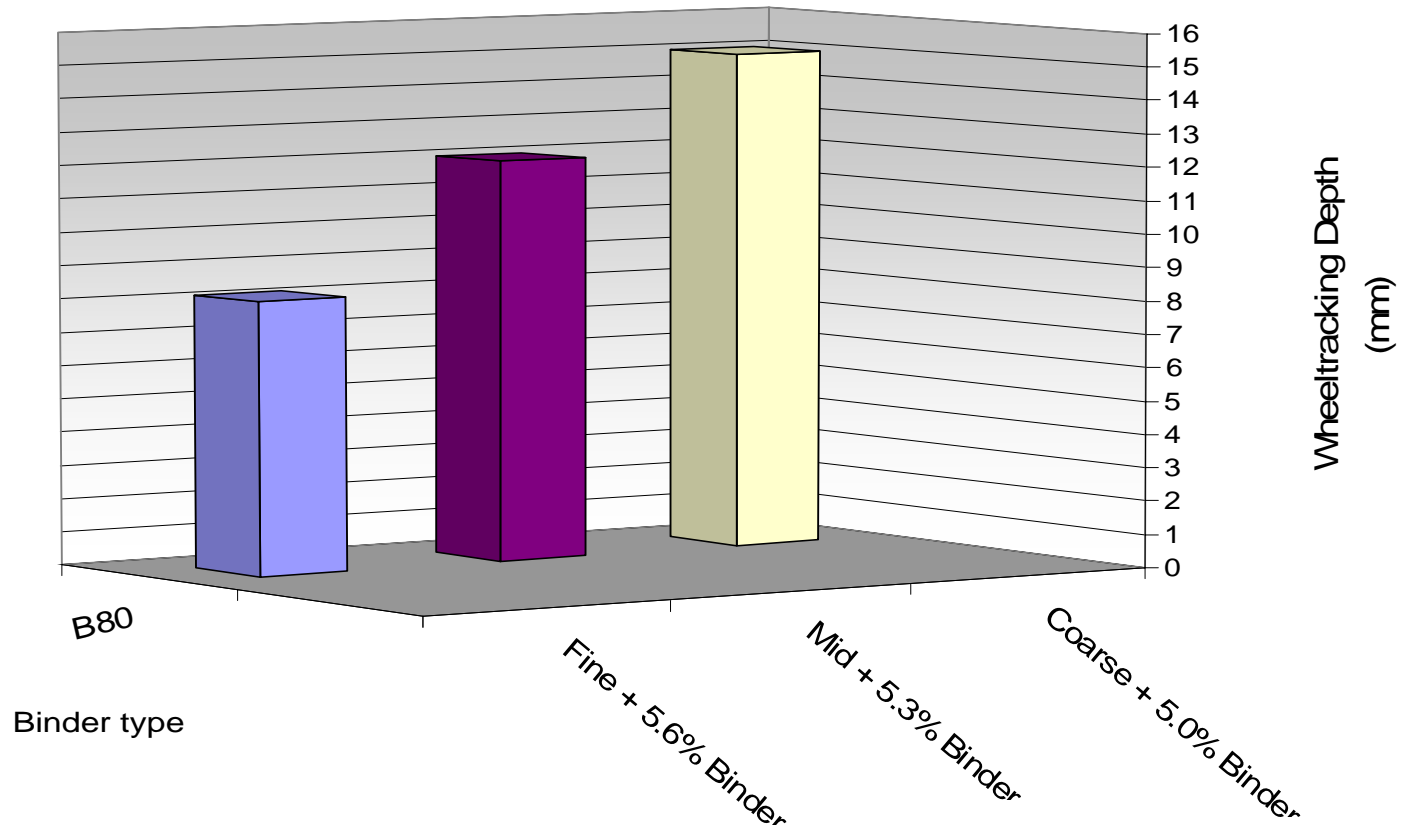
Asphalt Testing - AC14 B60 BB

Wheeltracking @ 60 °C after 10,000 passes

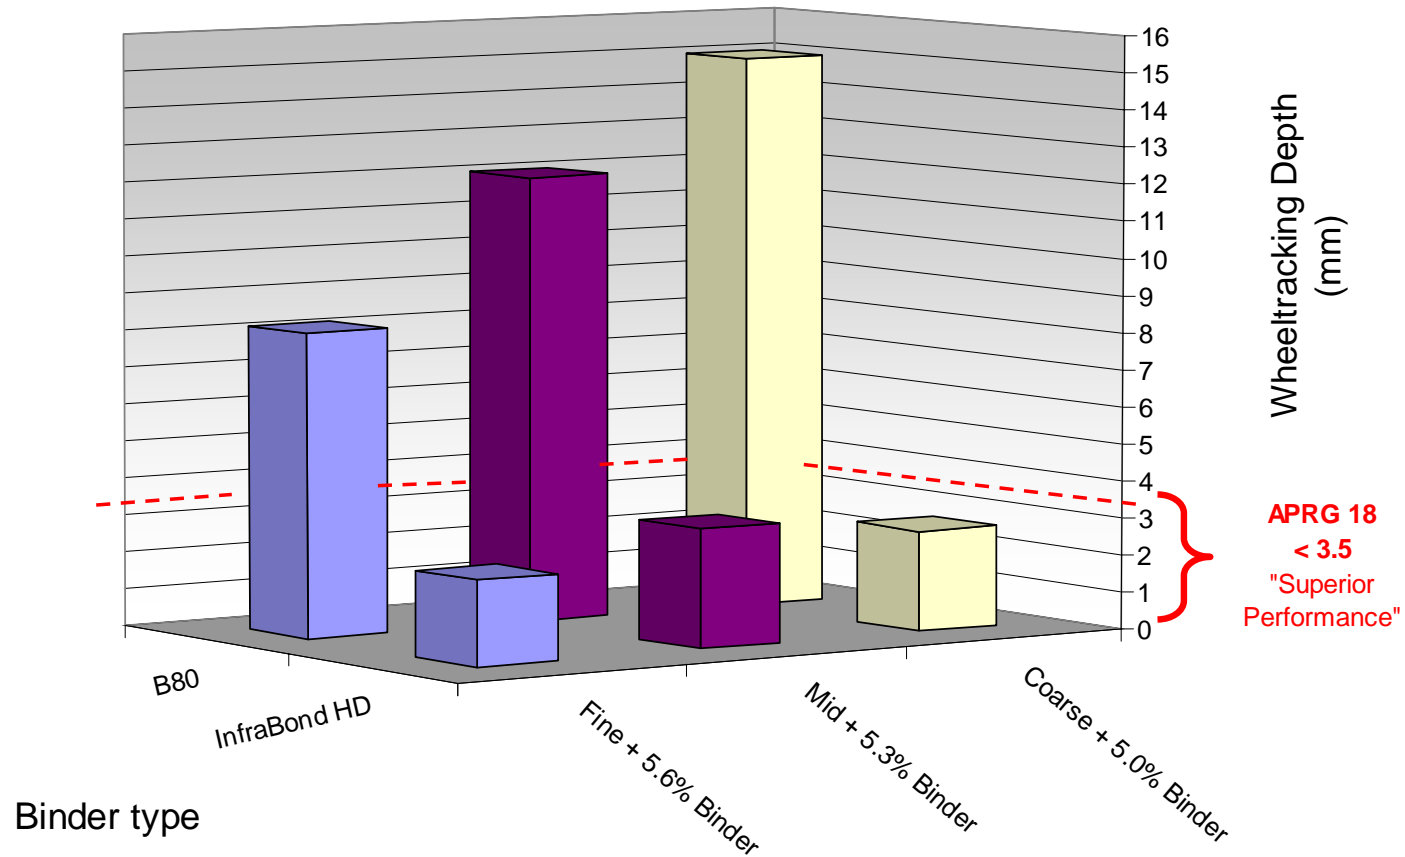
Asphalt Testing – AC14 B60 BB

Wheeltracking @ 60 °C after 10,000 passes
